**NEW MEXICO STATEWIDE COMMUNITY FOREST ANALYSIS
AND MANAGEMENT PLANNING
SOCORRO TREE INVENTORY
2017**

STATEWIDE COMMUNITY FOREST ANALYSIS AND MANAGEMENT PLANNING

NEW MEXICO ENERGY, MINERALS AND NATURAL RESOURCES DEPARTMENT
AND
THE CITY OF
SOCORRO, NM

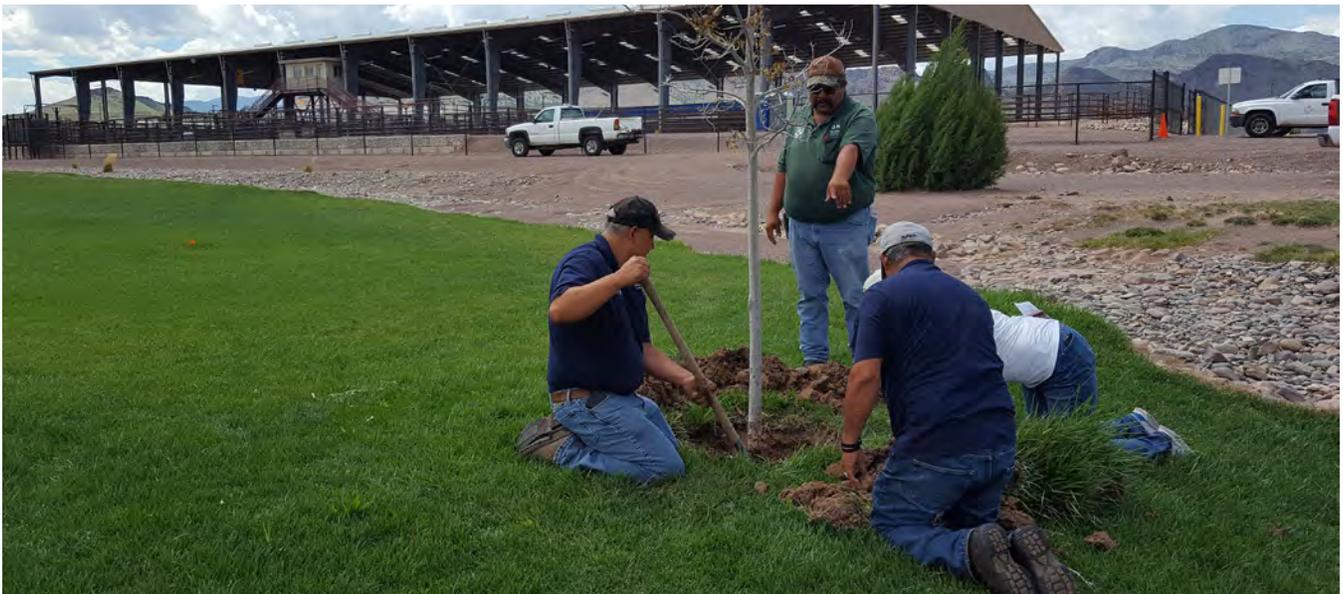
Dead Tree Planted Too Deep

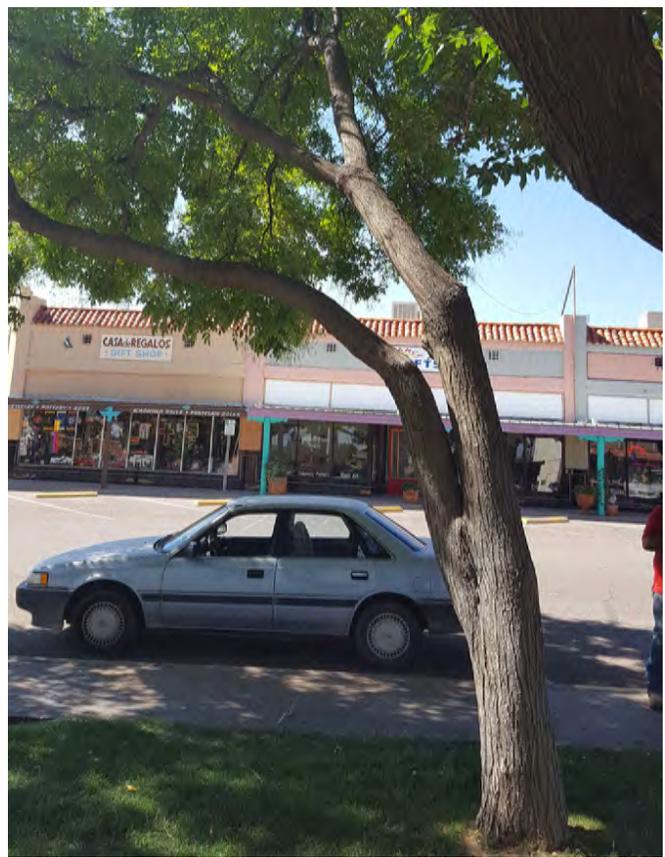
Tree Leaning to Reach Sunlight

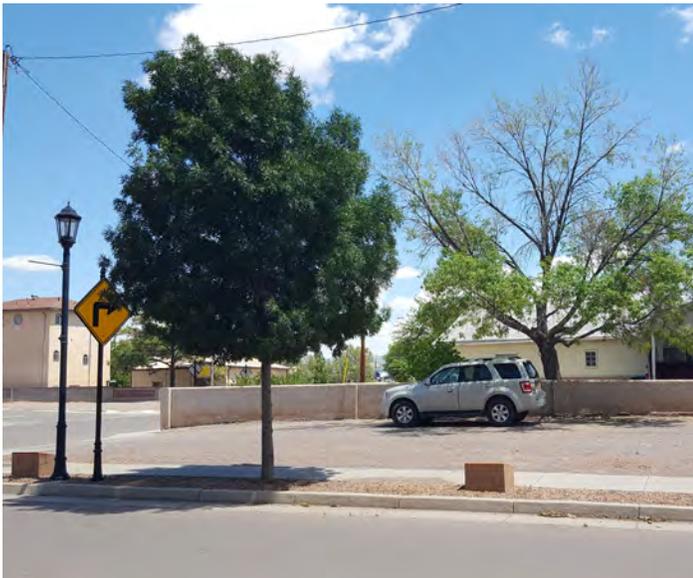
Trees in Good Condition and Poor Condition

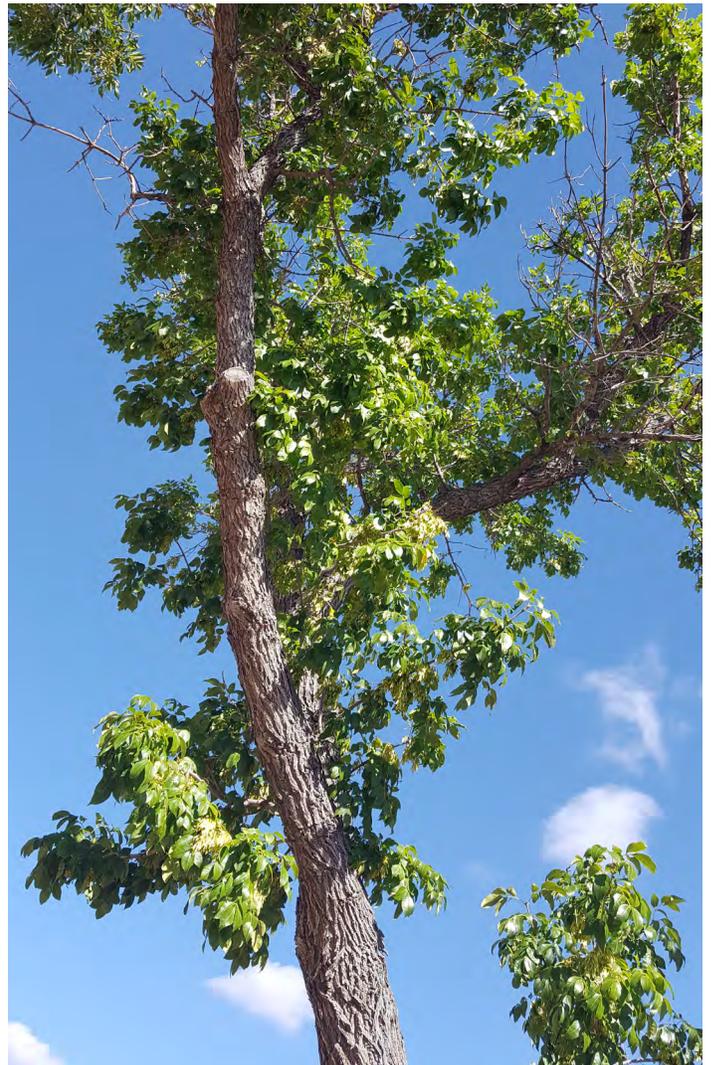
Poor Canopy Condition on Siberian Elm

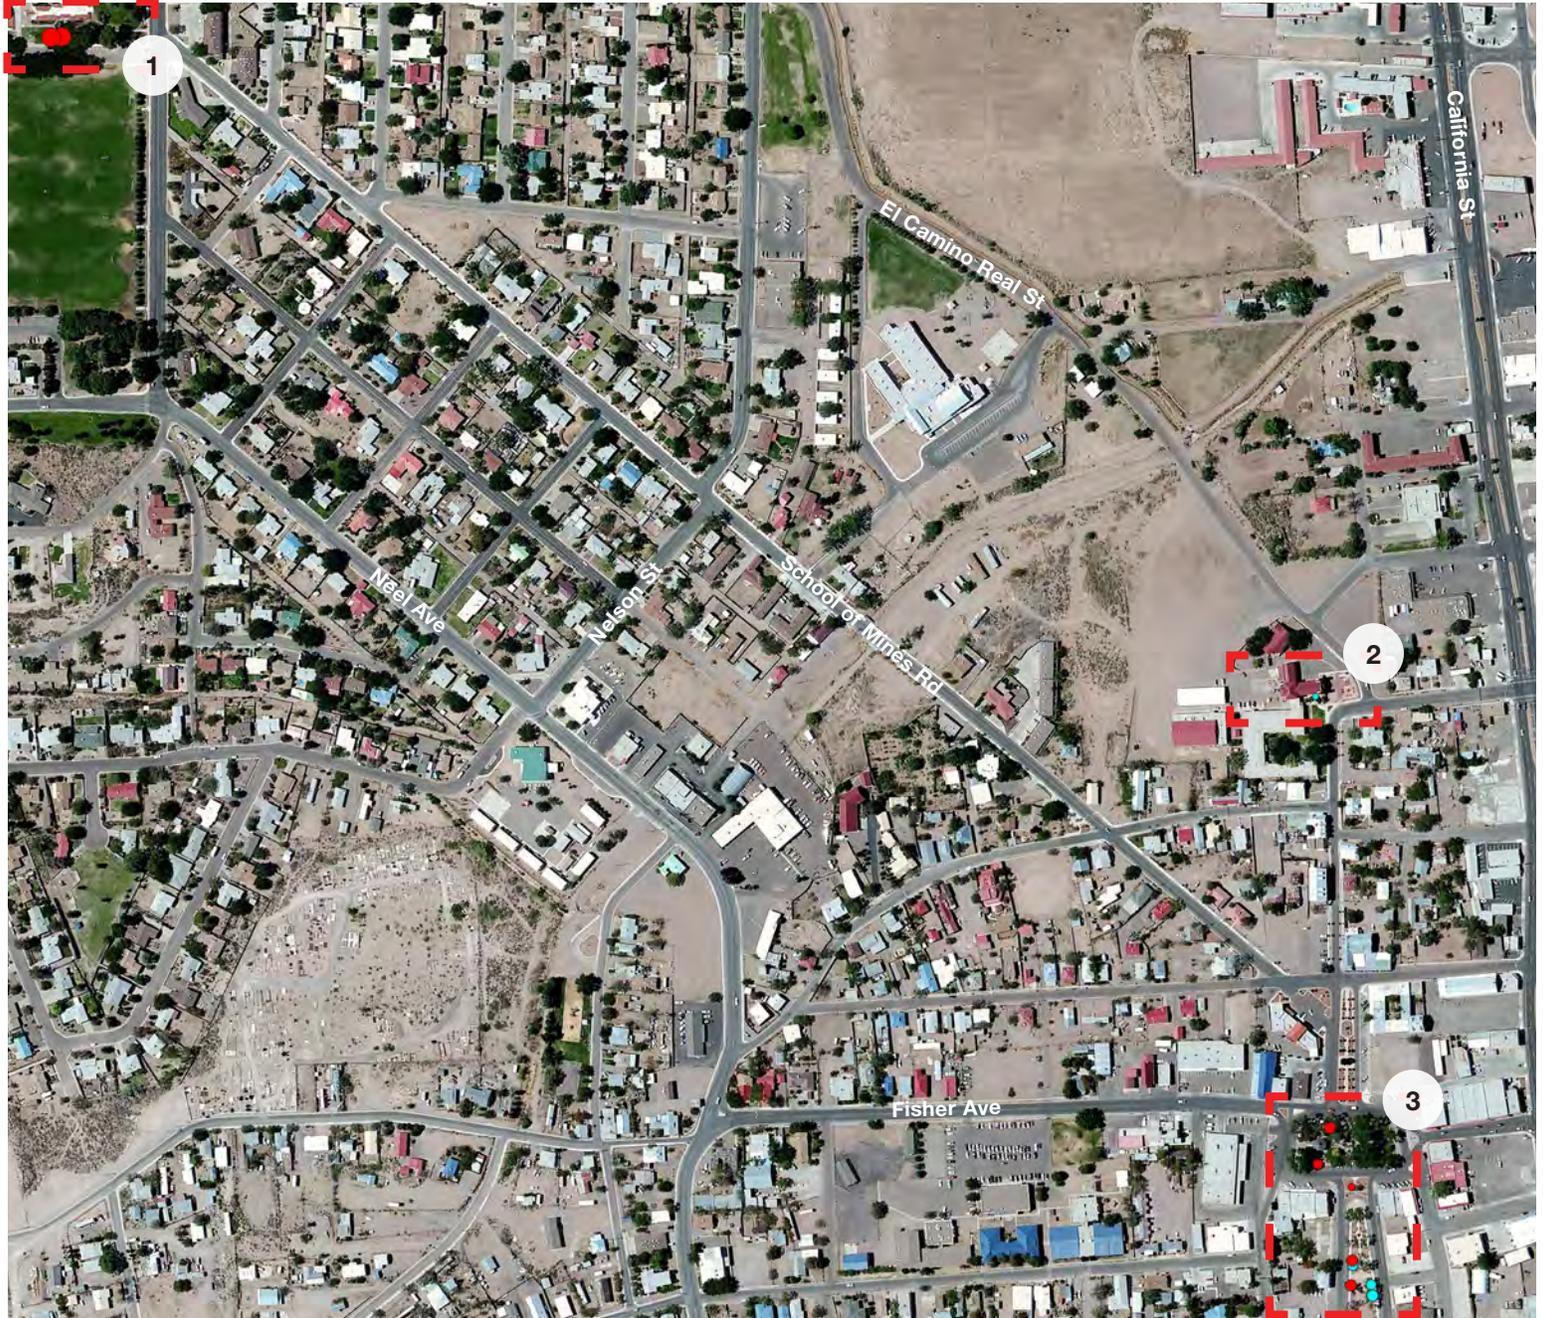
There are seven large trees that need immediate attention.
There are four trees that are recommended for removal.

Potentially hazardous trees.
